Manhole Inspection Summary

Manhole # S250O1016MH

Insp Date: **12/18/06 1:39 PM**

Location Address: **4615 ROLAND AVE**

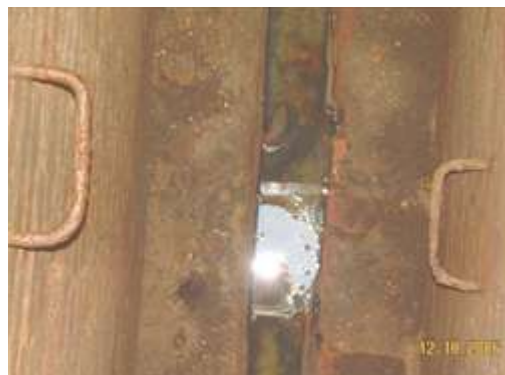
Top View

Bench ☒ Exists Material: **Brick** ☐ Parged ☒ **Debris** (not Condition related)

Channel Material: **Clay** ☐ Parged ☒ **Debris** (not Condition related)

Steps Count: **2** Missing: **0** ☒ **Corroded**

Corroded steps. Bench and Channel debris.

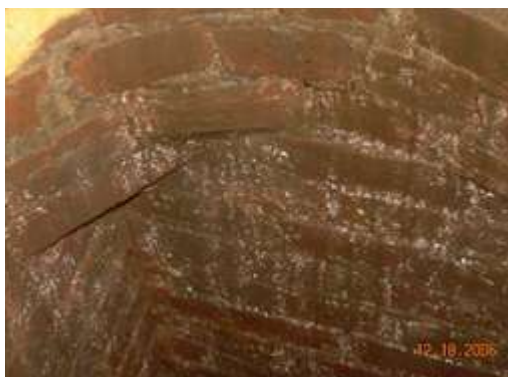
Defect

Infiltration: ☐ None ☒ **Joint** ☐ Cracks ☐ Mortar ☐ Roots ☐ Wall

Infiltration: ☐ None ☐ Joint ☐ Cracks ☐ Mortar ☐ Roots ☒ **Wall**

Adjustment and Corbel infiltration.

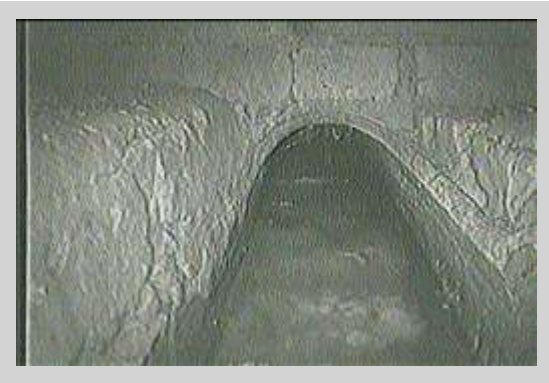
6 in. Circular Gravity Sewer Pipe Out @ 12 O'Clock

Deposits: ☐ None ☒ **Mud** ☐ Sludge ☒ **Debris** ☐ Grease

Silt Depth: **2** (in.) Deposits Extent: **Light**

Infiltration: **Evidence** Pipe Seal Cond: **Cracked**

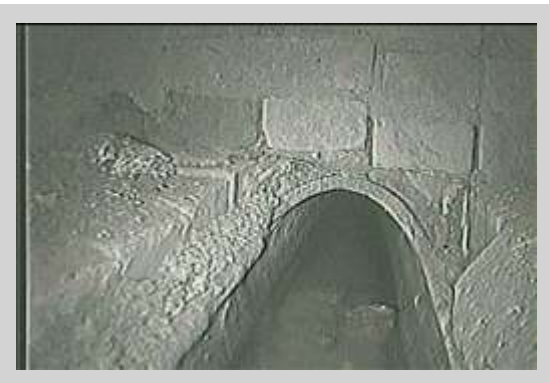
6 in. Circular Gravity Sewer Pipe In @ 6 O'Clock

Deposits: ☐ None ☒ **Mud** ☐ Sludge ☒ **Debris** ☐ Grease

Silt Depth: **0** (in.) Deposits Extent: **Light**

Infiltration: **None** Pipe Seal Cond: **Unknown**
